### Unbonded post tensioned concrete in fire: A review of data from furnace tests and real fires

## **Unbonded Post Tensioned Concrete in Fire: A Review of Data from Furnace Tests and Real Fires**

**Key words:** Prestressing steel; Post-tensioned slabs; Unbonded construction; Fire endurance testing; Spalling; Concrete; Concrete cover; Case studies.

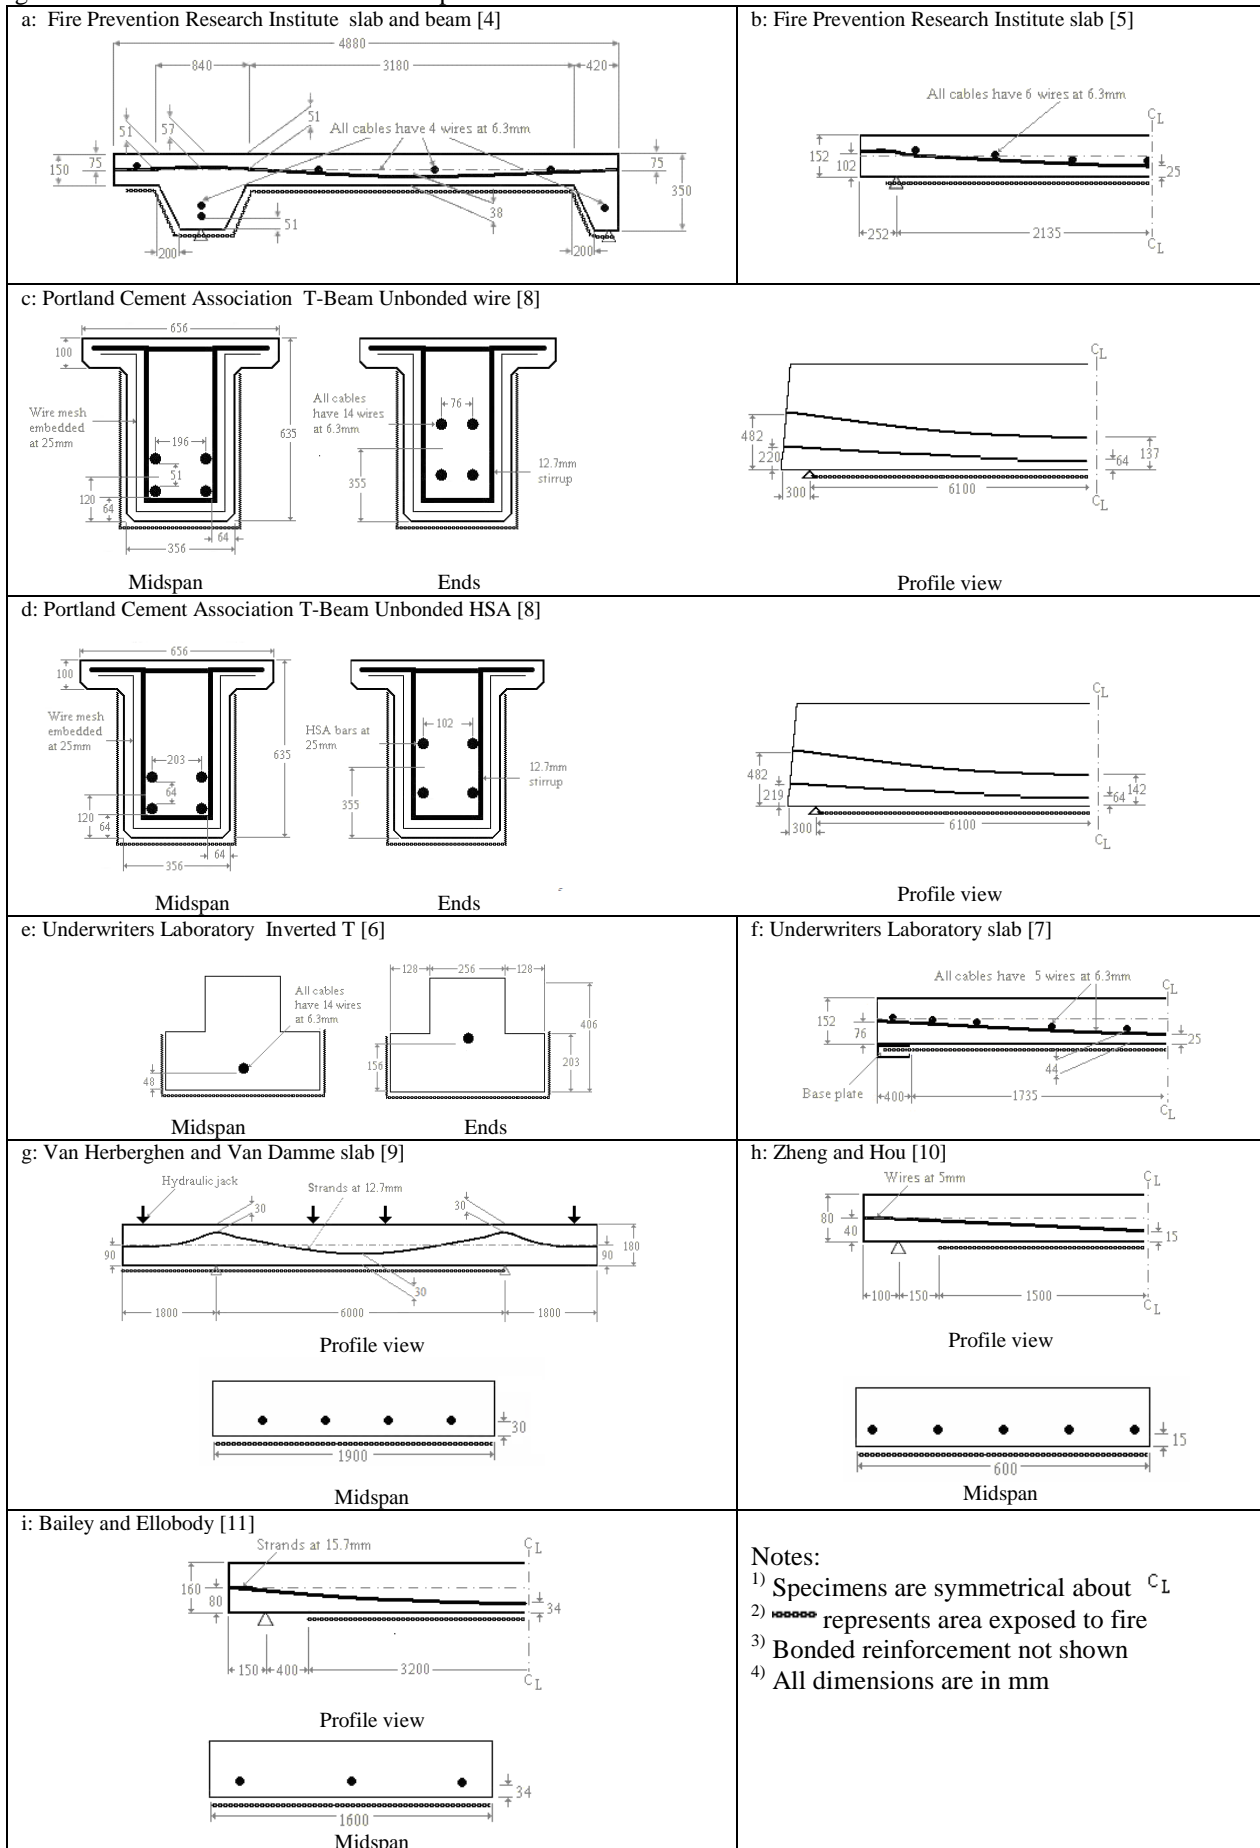
Figure 1: Selected details of furnace test specimens available from the literature

In 1959, FPRI conducted a second fire test of a similar two-way UPT slab panel (without beams). The original testing report is not readily accessible [5], although general descriptions of the test are available elsewhere [40-42]. Figure 1b shows the tested assembly, which consisted of a 152 mm deep siliceous aggregate concrete flat slab panel spanning 3910 mm by 4270 mm and supported on pins at its corners. The slab was prestressed with draped UPT cables in both directions. The minimum clear concrete cover to the UPT cables, each of which consisted of six 6.3 mm diameter wires, was 38 mm in the larger spanning direction at midspan. The tendons were stressed to 990 MPa. No mild steel reinforcement was provided within the spans. The slab was subjected to a uniformly distributed superimposed load corresponding to 1.0 times the design live load and exposed to the E119 [35] fire, again using laterally-restrained conditions in both spanning directions. The RH in the slab at the time of testing was 76% ( $\approx 2.3\%$  by mass) at an unknown depth, and the concrete compressive strength was 30 MPa.

In 1964, as part of a larger study on the fire performance of various types of concrete beams, the Fire Research Laboratory of the Portland Cement Association (PCA), Illinois, conducted two standard furnace tests of UPT beams with T-shaped cross sections [8, 41, 42]. The beams' cross-sections are shown in Figures 1c and 1d; they were essentially rectangular, with a depth of 635 mm, a web width of 356 mm, and small flanges of 150 mm  $\times$  100 mm. One beam (Beam 80) was prestressed with four draped UPT high strength alloy bars, each with a diameter of 25 mm and an ultimate strength of 1168 MPa, prestressed to 770 MPa. The other beam (Beam 76) was prestressed with four draped UPT cables, each consisting of fourteen 6.4 mm diameter wires with an ultimate strength of 1760 MPa, prestressed to 1168 MPa. In both cases the minimum clear cover at midspan was 64 mm on both the soffit and the sides.

Details of a typical specimen tested by Van Herberghen and Van Damme [9] are shown in Figure 1g. Also shown is a schematic of the test setup, support and loading conditions, and fire exposure. The eight one-way slab strips were 180 mm thick by 1900 mm wide, and approximately 9000 mm in total length. Longitudinally they all had draped 12.7 mm nominal diameter longitudinal seven-wire prestressing tendons, with 1150 MPa initial prestress levels, and all were continuous over two internal supports with a central span of about 6000 mm and cantilever spans at each end. Only the central span and one cantilever were exposed to fire. Several parameters were varied amongst the specimens:

The slabs were loaded during testing using four hydraulic jacks (as shown in Figure 1g) to produce “a condition of zero rotation at the supports.” Exactly how and why this loading condition was chosen is unclear. As a consequence of this rather unusual support condition, the applied load (and hence the bending moments at the critical sections) varied throughout the tests – it seems unlikely that this was any more representative of full-structure response in a real fire than a restrained standard fire test on an isolated structural element with constant vertical load. The initial load was chosen to simulate a comparatively high uniformly distributed superimposed live load of 4.9 kPa. In the paper describing these tests, Van Herberghen and Van Damme [9] comment that “the importance of the initial bending moments was of minor influence on the ultimate fire resistance.” It is not clear exactly what is meant by this, but it appears from the data presented that the evolution of bending moments during the fire exposure was far more important in governing the slabs’ collapse than the initial loading condition. This is of considerable interest, since the initial load ratio is universally assumed to be of central importance to the structural fire resistance of a flexural assembly in a standard furnace test – to the extent that larger fire endurance are assigned to assemblies with lower load ratios for some types of construction [42, 45]. This confirms the increasingly widespread notion that full-structure interactions in fire are likely to be more significant than the capacities of isolated members as demonstrated through standard furnace tests.

Zheng and Hou [10] report on nine standard furnace tests on small-scale (model), one-way spanning UPT slab strips prestressed with steel wires. Figure 1h provides details of a typical tested assembly. All specimens were fabricated from carbonate aggregate concrete with a width of 600 mm and spanning 3300 mm between simple supports. The prestressing consisted of between two and five prestressing wires, each with a diameter of 5 mm and an ultimate tensile strength of 1722 MPa. The wires were prestressed to between 655 MPa and 1022 MPa prior to testing. A clear concrete cover of 15 mm, 25 mm, or 30 mm to the prestressed reinforcement was provided for the 80, 90, and 95 mm thick slabs, respectively. Varying amounts of mild steel longitudinal reinforcement were provided within each of the slabs; the mild steel longitudinal reinforcement ratio varied between 0.20% and 0.45%. All slabs had mild steel transverse reinforcement with the same clear cover as the prestressed reinforcement at midspan, and with a reinforcement ratio of about 0.17% to 0.20% depending on their thickness.
